DEPARTMENT OF NATURAL RESOURCES
DIVISION OF OIL, GAS AND MINING

RE: Site Inspection, Minerals Investigation Development Company, Organa Claims, S/055/013, Wayne County, Utah

Date of Inspection: December 13, 2002
Time of Inspection: 10:15-10:25 a.m.
Conditions: Mostly clear, 30's
Participants: Paul Baker, DOGM

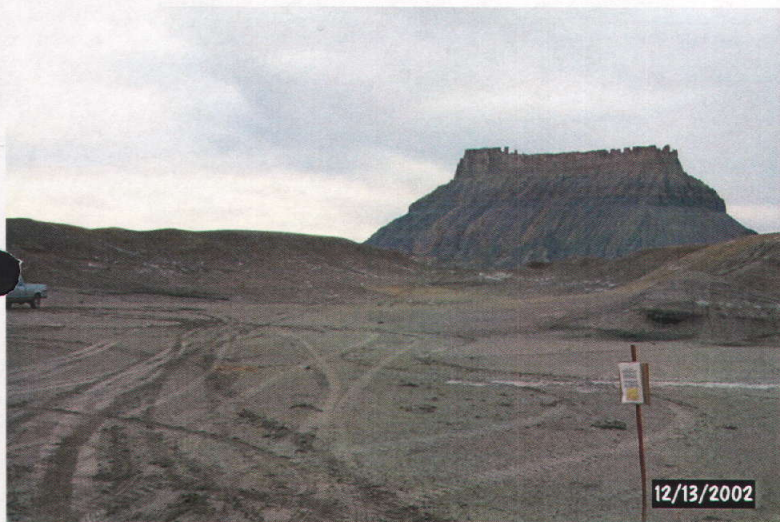
After Tony inspected this site in 1998, the Division received a letter from the operator indicating they had not mined in this area for several years but that they had discovered disturbance from an unknown party near their restored area. I was able to find the disturbance Tony found but nothing else. Photo 1 is a view that matches very closely with photos Tony took in both 1996 and 1998. For this reason, I am not completely certain that the area I inspected was the mine for which the Division has a notice of intention.

The surface of the area I found was slightly corrugated but otherwise blended well with surrounding topography (Photos 1 and 2). There is almost no vegetation in this area, so it was impossible to tell the site had been disturbed or how long it had been since it was regraded based on

Photo 1. View looking toward Factory Butte. This view is nearly the same as in photos Tony Gallegos took in 1996 and 1998. The area shown in Photo 2 is just to the right of the truck on the left side of this photo.

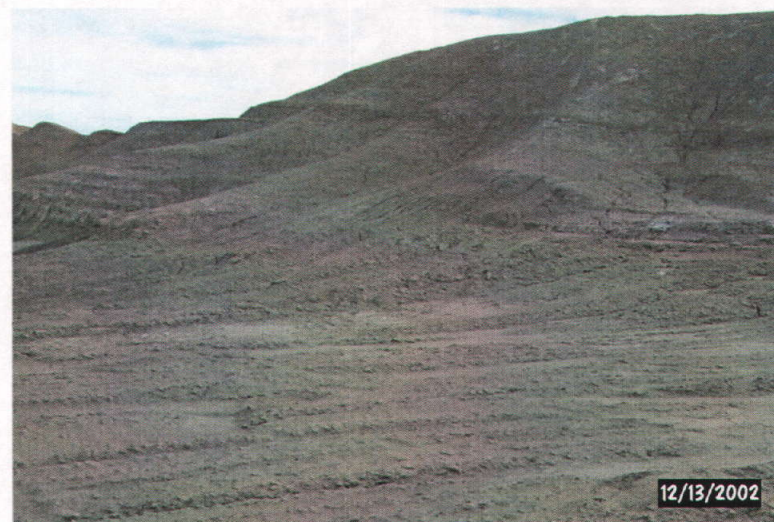
Photo 2. Regraded (corrugated) area., Note how well it blends with surrounding areas.

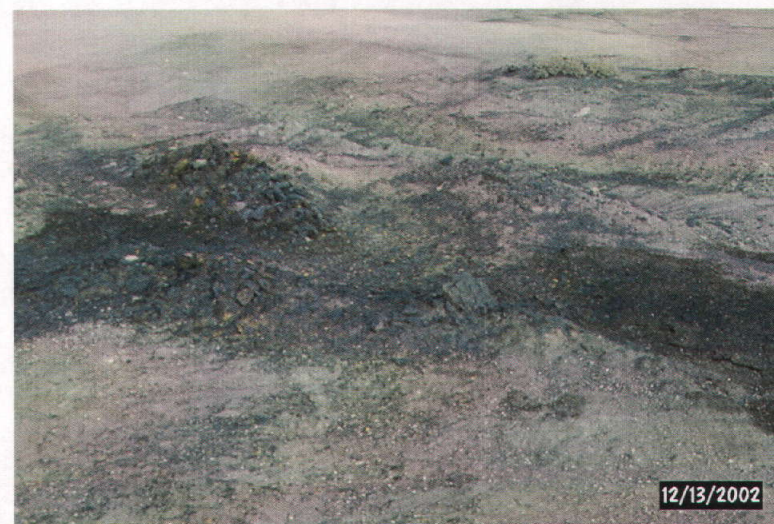
vegetation. I was also able to find some evidence of someone digging in the carbonaceous shale (Photo 3), and this may be the samples discussed in the annual report for 2001 (see below).

Photo 3. Exposed carbonaceous shale where it appears someone has been digging recently.
